INDOOR AIR QUALITY ASSESSMENT

**Melrose Veterans Memorial Middle School
350 Lynn Fells Parkway
Melrose, Massachusetts**

Prepared by:
Massachusetts Department of Public Health
Bureau of Environmental Health Assessment
October 2002

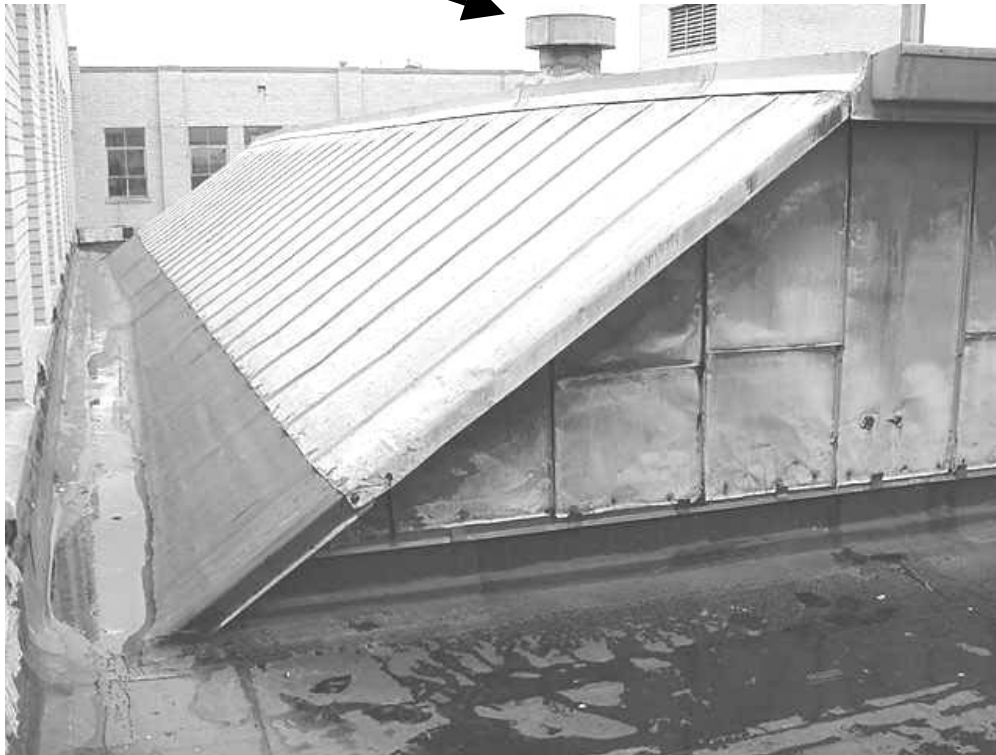
Picture 1.

Univent Air Intake Vent

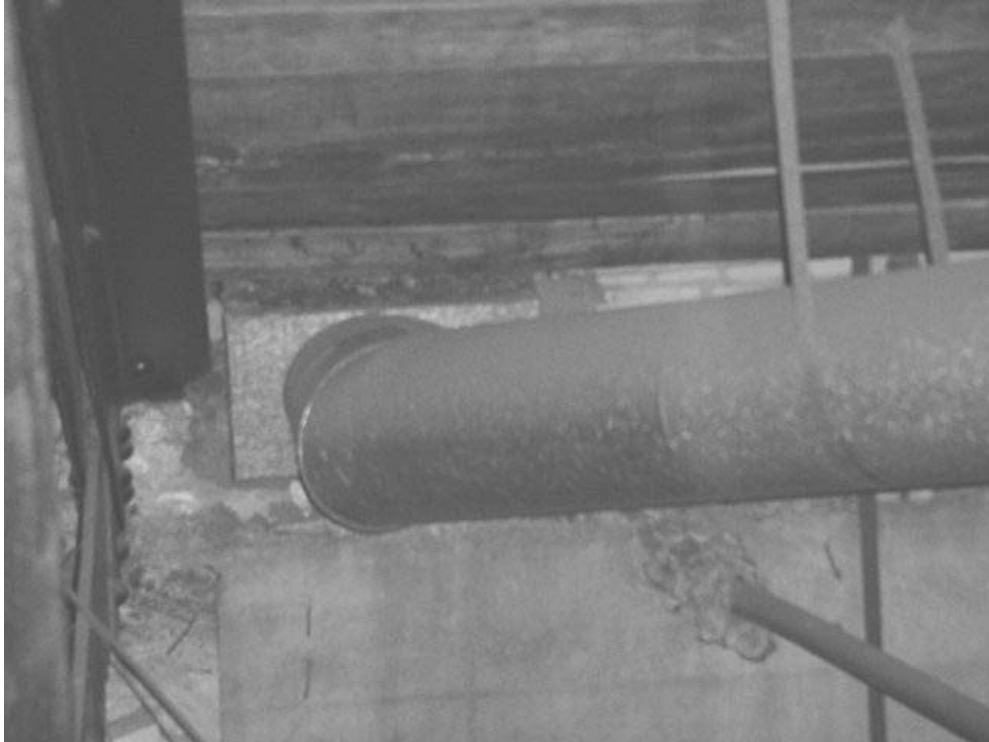
Picture 2

Penthouse Containing Supply Ductwork for Univent System

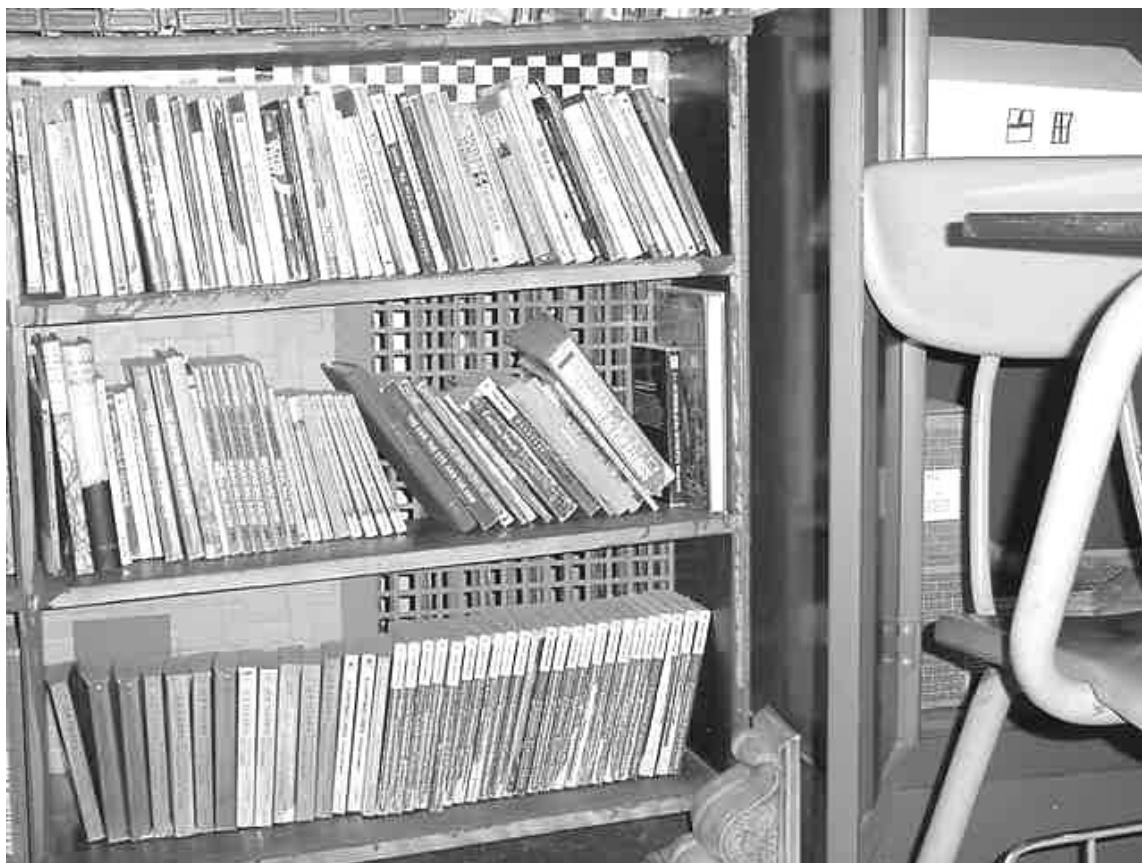
Picture 5

Univent Air Intake, Sealed with Plywood

3. Regularly inspect exhaust motors and belts for proper function, repair and replace as necessary.
4. Remove all blockages from univents and exhaust vents.

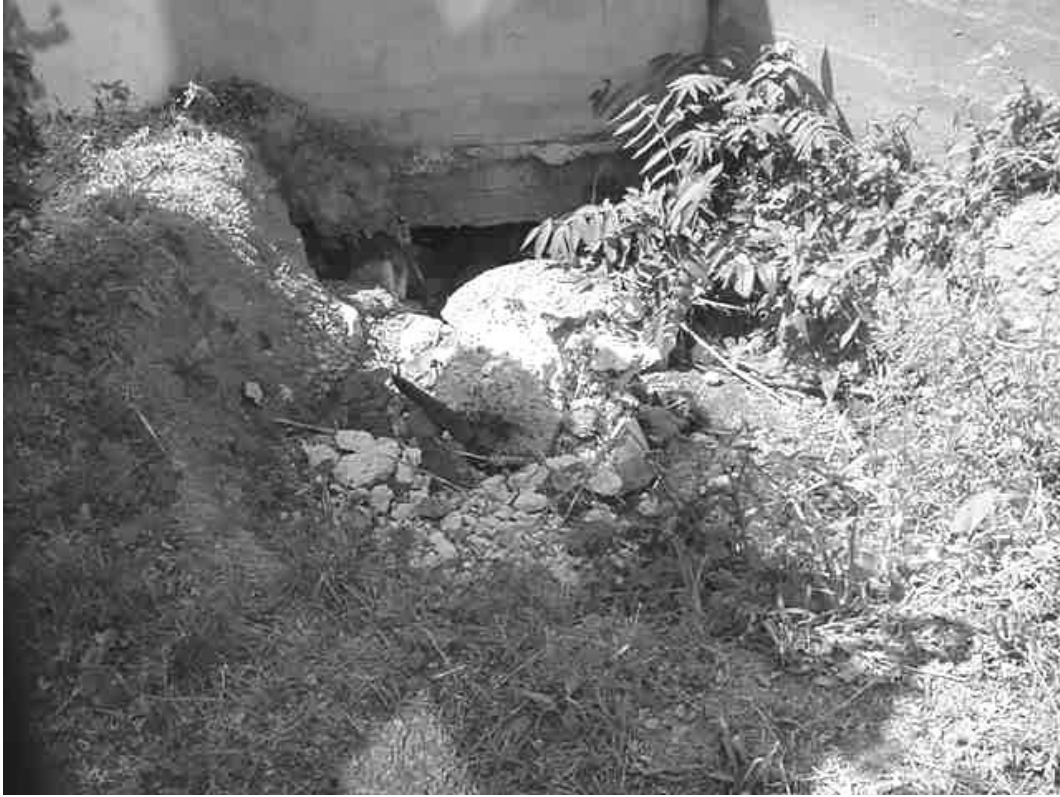
Picture 6

The school has a history of flooding problems. Along the edge of the foundation of the building are a series of holes that are a minimum, three feet below ground level (see Pictures 6 & 7). These holes appear to be signs of water draining beneath the foundation. These types of holes can be created by water scouring the soil, as it drains towards the building. Scouring is the removal of soil by moving water during erosion. In addition, the holes showed signs of subsidence, leaving behind water-filled holes against/under the foundation. Subsidence is caused by either compaction of organic soils as the ground/fill settles or when materials (e.g. water) are withdrawn from under the ground, causing the land surface to sink (FEMA, 1987). There appear to be several factors that contribute to this condition.

3. A concrete walkway was installed along the outer edge of the driveway that leads to the front door of the MVMMS. The walkway is at a ***higher level*** than the ground between this walkway and the foundation. This configuration would prevent water accumulating along the edge of the MVMMS from draining. In essence, the concrete walkway serves as a dam to hold water against the foundation. Without proper pitch and pathways, the only available route for water to drain from the edge of the foundation is under the foundation, through the holes in Pictures 6 & 7.

Obstructed Exhaust Vent

1. Prior to any repair of the building envelope, the following evaluations should be considered:
 - a. An examination of water drainage beneath the foundation on the structure of the building.
 - b. An examination by a civil and/or building engineer of the best method to redirect water away from the foundation of the MVMMS. This evaluation should include an analysis on how the concrete walkway can be redesigned to aid water drainage from the foundation of the building.

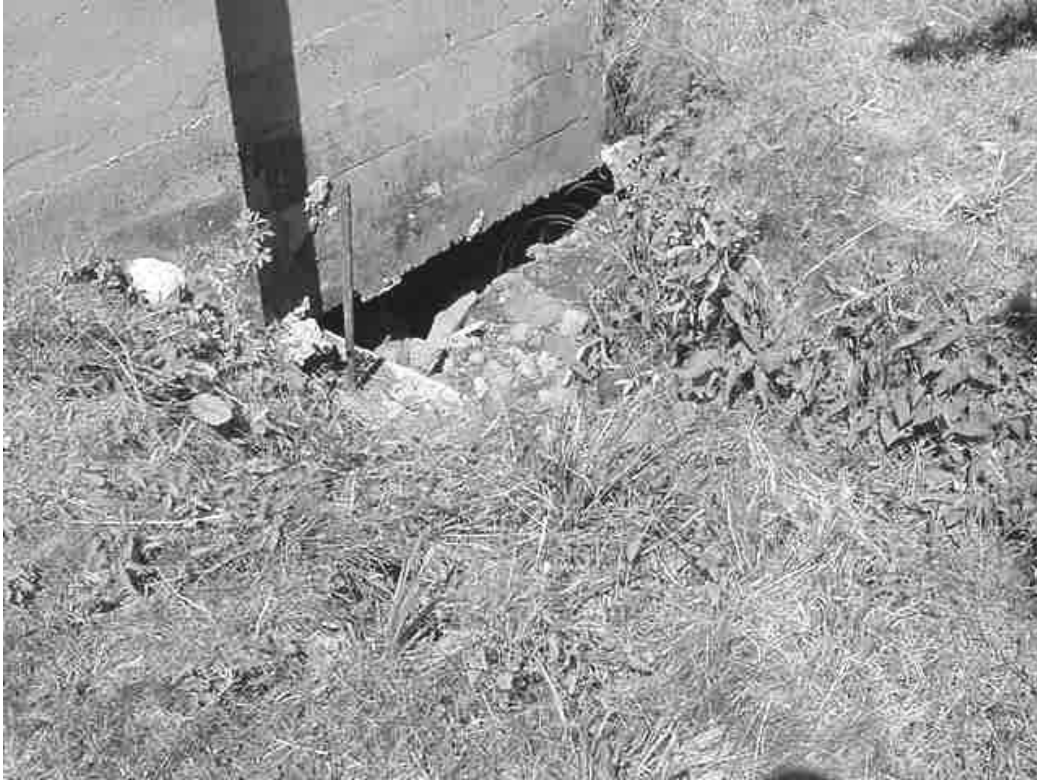
Picture 7

Hole at Foundation of Melrose Middle School Building

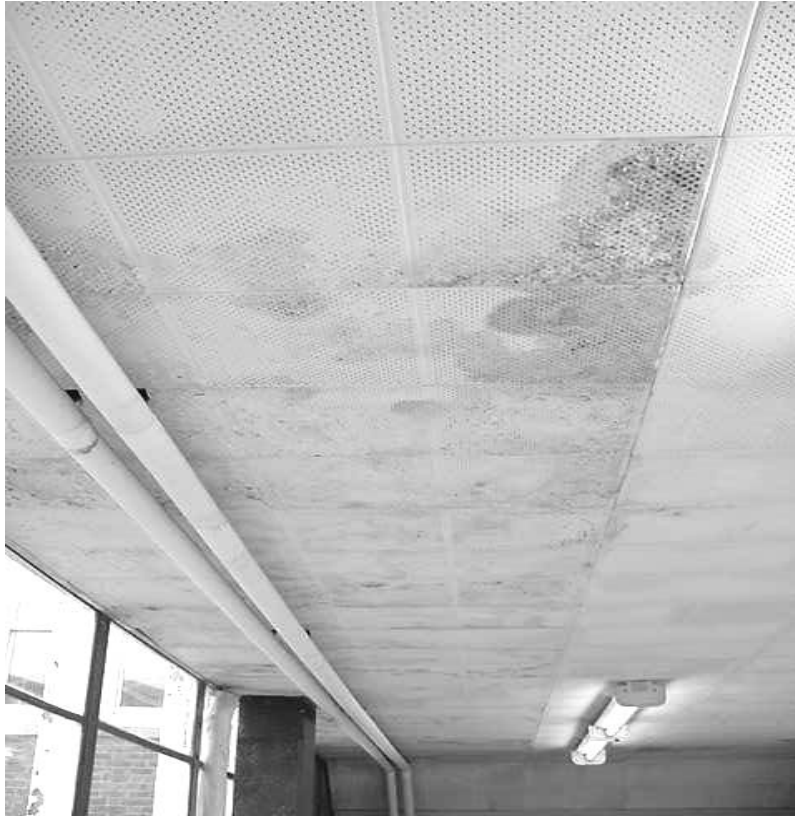
Picture 12

A number of rooms had water-stained ceiling tiles, which are evidence of historic wall, roof or plumbing leaks (see Picture 12). Water-damaged ceiling tiles can also provide a source of microbial growth and should be replaced after a water leak is discovered. A particular area of heavy water damage is the enclosed walkway connecting the main building to the annex.

Water Damage in Exhaust Vent

9. Replace any remaining water-stained ceiling tiles, wall plaster and building materials. Examine the area above and around these areas for mold growth. Disinfect areas of water leaks with an appropriate antimicrobial.

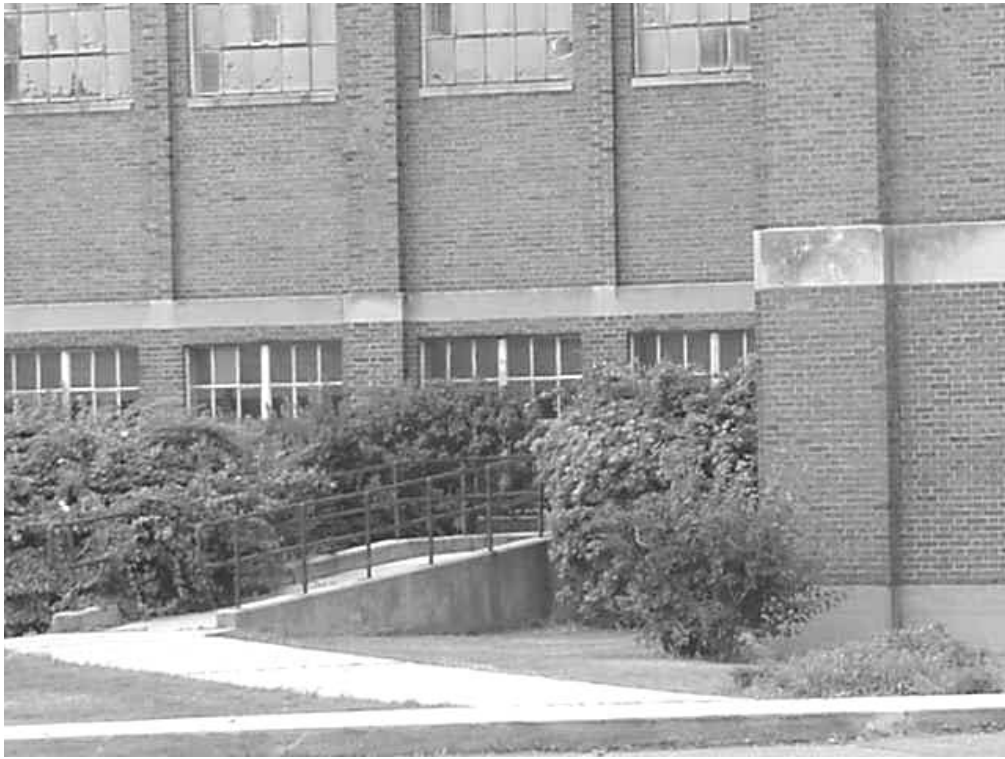
Picture 13

Other conditions were noted that may allow for water to penetrate into the building. Shrubbery was noted growing within close proximity or in contact with exterior walls (see Picture 13). In addition, the growth of roots against the exterior walls

can bring moisture in contact with wall brick and eventually lead to cracks and/or fissures in the foundation below ground level. Over time, this process can undermine the integrity of the building envelope and provide a means of water entry into the building through capillary action through foundation concrete and masonry (Lstiburek, J. & Brennan, T.; 2001).

Water Damaged Ceiling Tiles in Annex Walkway

10. Move plants away from univents in classrooms. Ensure plants have drip pans and examine drip pans for mold growth. Disinfect with an appropriate antimicrobial where necessary. Remove foliage at least five feet away from the foundation.

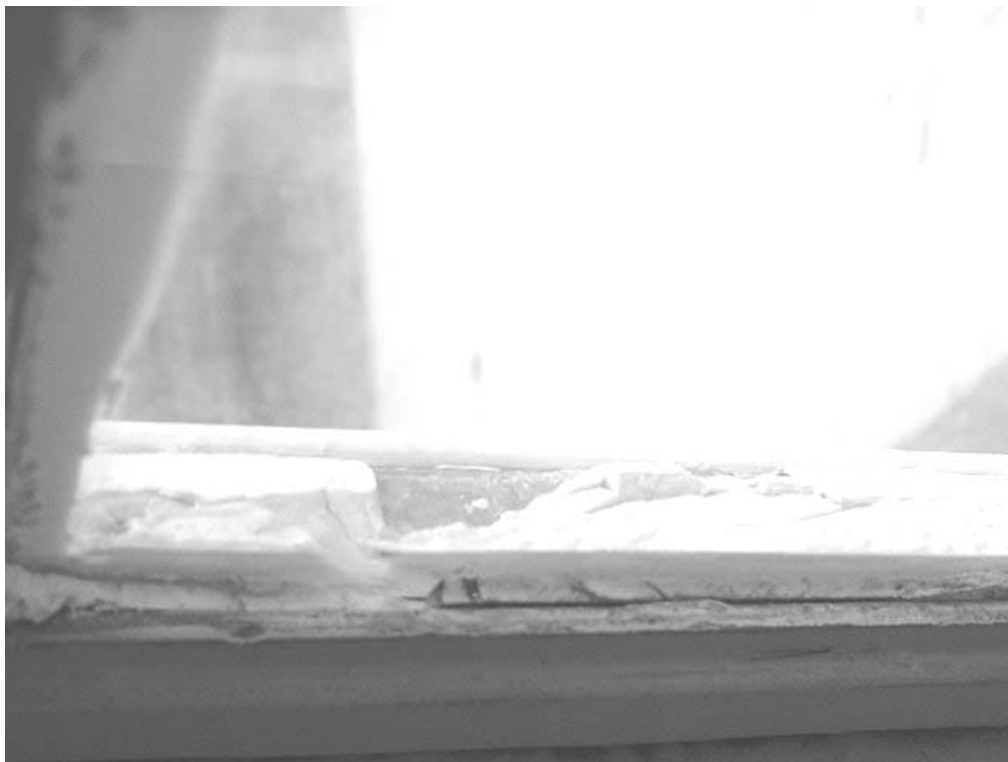
Picture 14

Throughout the school, caulking around the interior and exterior windowpanes was crumbling, missing or damaged (see Pictures 14 & 15). Several rooms contained loose fitting windowpanes and/or cracked or broken windows. Air infiltration was noted around windows. Many areas had water damaged wall plaster and other building materials, which most likely resulted in chronic water penetration through improperly sealed windows. Water penetration through window frames can lead to mold growth under certain conditions. Repairs of window leaks are necessary to prevent further water penetration. Repeated water damage can result in mold colonization of window frames, curtains and items stored on or near windowsills.

Shrubbery in Close Proximity to Building

4. Repair/replace broken and/or loose windows and replace missing or damaged window caulking to prevent water penetration through window frames.

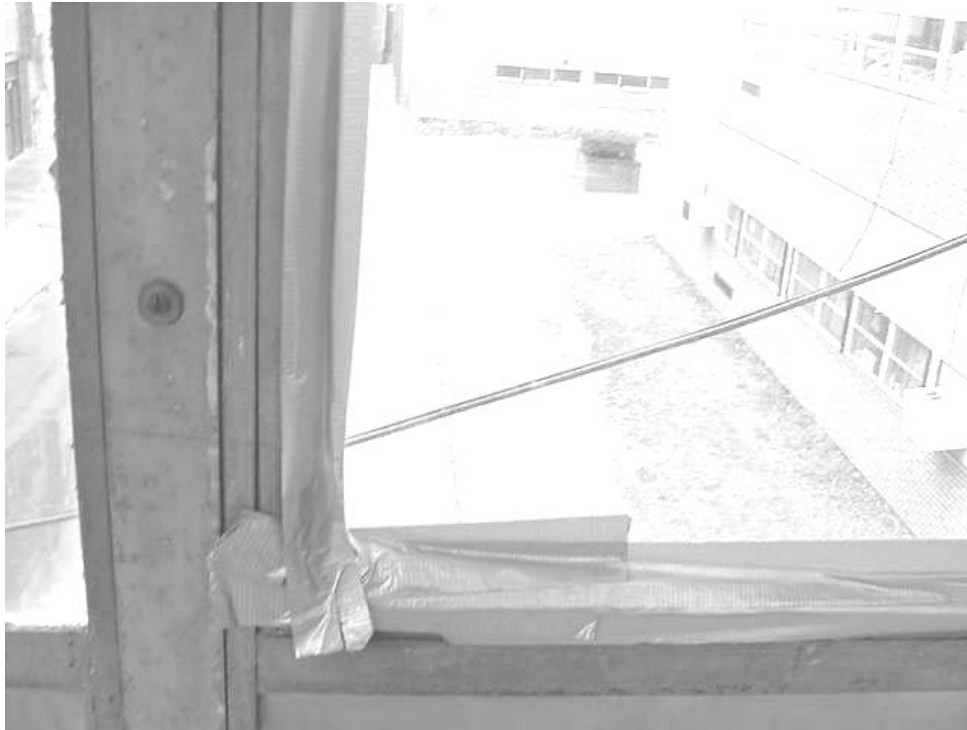
Picture 15

Missing/Damaged Window Caulking

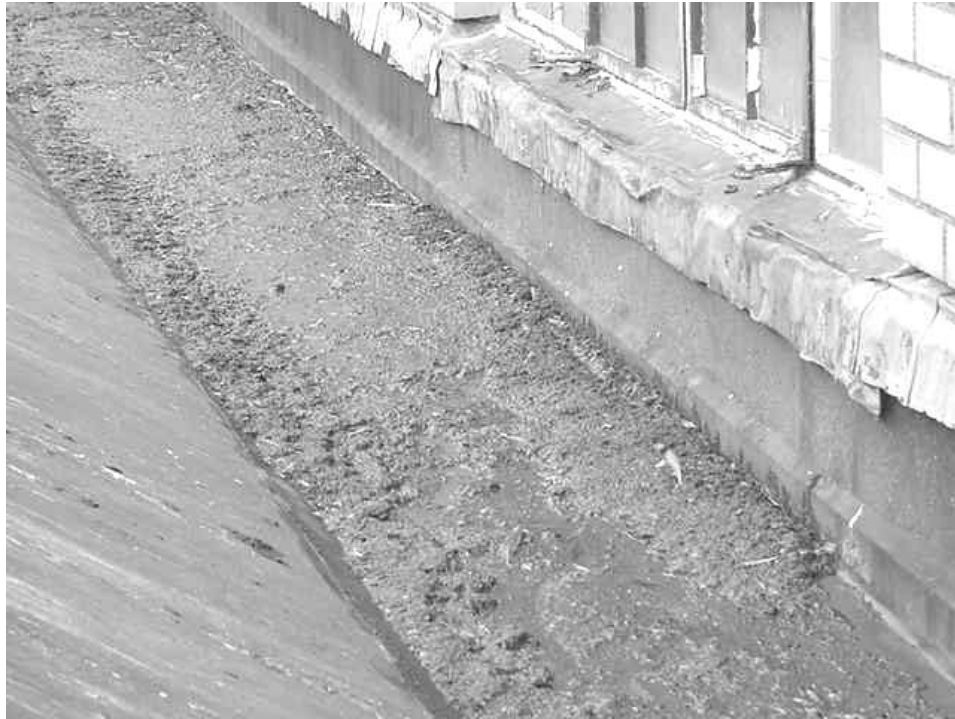
Picture 16

Standing water and accumulated debris was noted in a number of areas on the roof. In particular, on the lower roof of the main building, a trough is formed between the exterior wall and the univent penthouse (see Picture 16). The collection of water and its subsequent freezing and thawing during winter months can lead to roof leaks resulting in water penetration into the interior of the building. Pooling water can also become stagnant, which can lead to mold and bacterial growth, resulting in unpleasant odors and providing a breeding ground for mosquitoes in warmer months.

Windows Frames Sealed with Duct Tape (Missing Damaged Caulking)

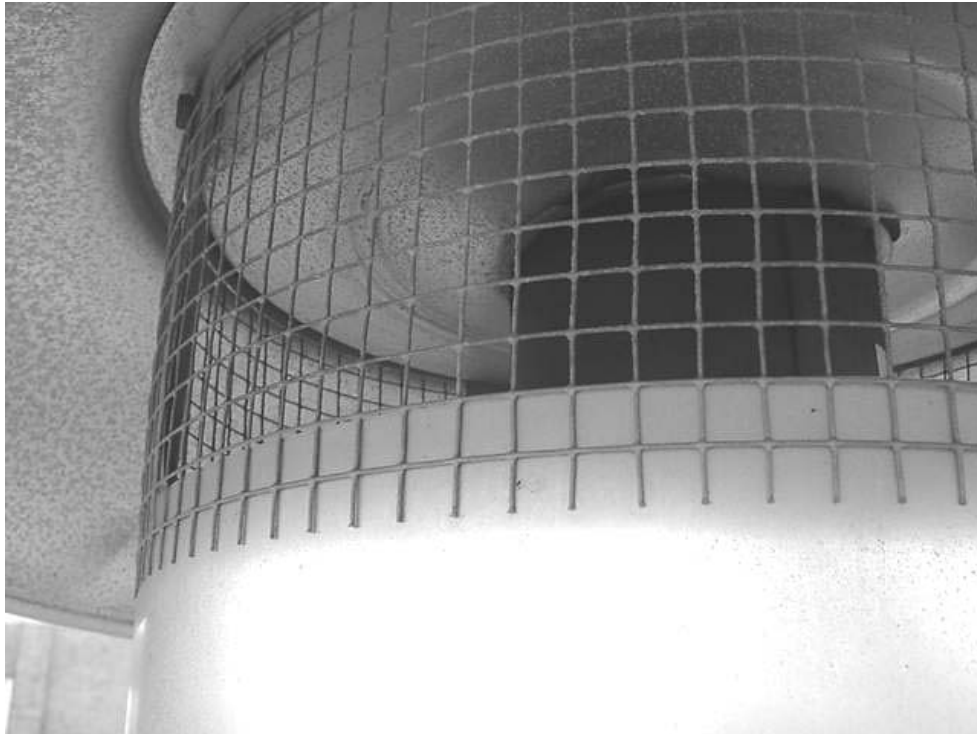
Picture 17

At the time of the BEHA assessment, pigeon wastes had reportedly been cleaned and screens were installed on rooftop exhaust motors to prevent bird egress. BEHA staff conducted an inspection of the rooftop ventilation components for evidence of bird wastes/roosting. At the time of our inspection, BEHA staff observed no evidence of further roosting of birds within rooftop ventilation equipment. Exhaust vents were outfitted with wire screens attached to the vent housing to allow airflow and prevent the egress of pigeons. In most cases screens were fit flush or close to the housing of the vent

opening (see Picture 17), however in several instances spaces of 1-2 inches were noted between the screens and vent housing (see Picture 18).

Standing Water and Accumulated Debris in Trough on Roof,

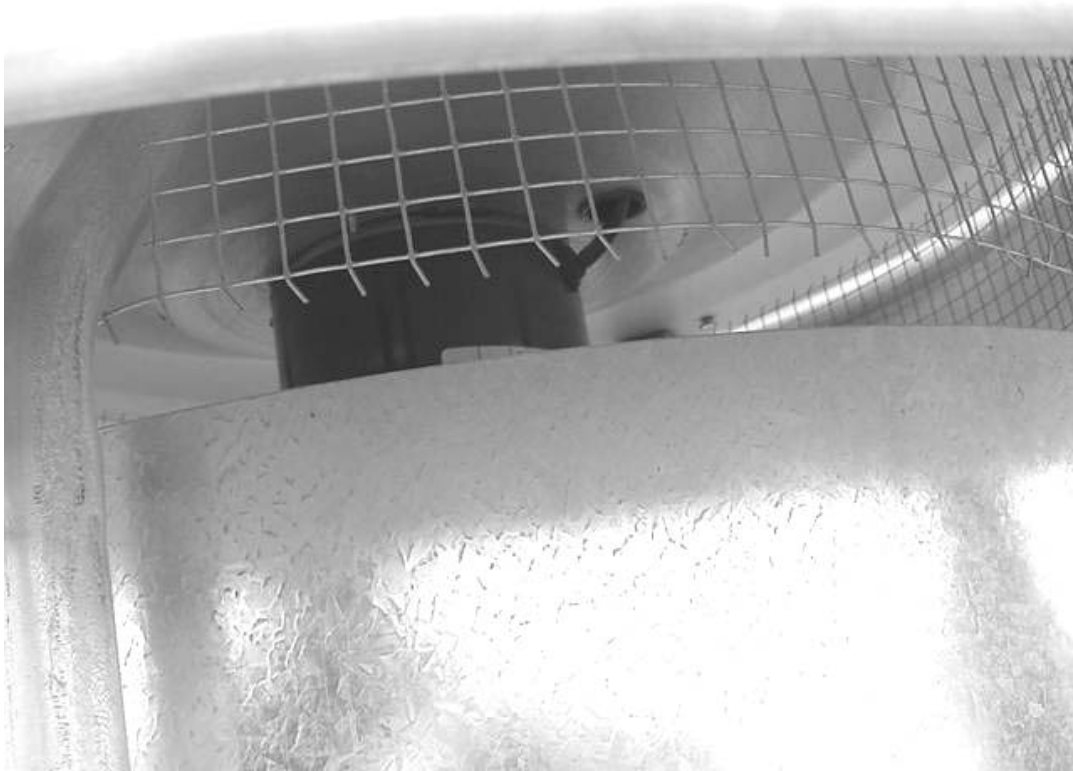
Picture 18

Rooftop Exhaust Vent Bird Screen, Note Screen Overlaps Housing

7. Extend wire bird screens installed on exhaust vents to fit flush with vent housing or cover existing spaces with wire mesh to prevent egress.
8. Inspect all rooftop vents regularly for integrity and repair as needed. Consider numbering vents and create a checklist for maintenance personnel to sign off on.

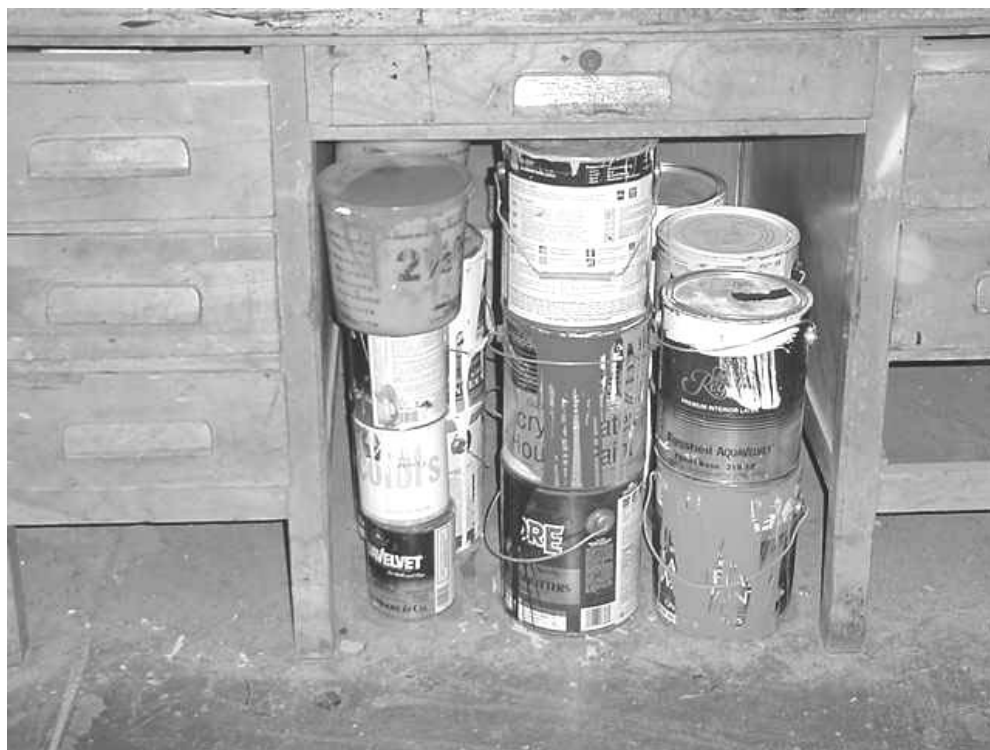
Picture 19

Also noted in the woodshop and in adjacent rooms currently used for storage, were cans of shellacs, wood finishers and paint thinners (see Picture 19). Several cans in this area appear to be corroded, which can lead to container failure (see Picture 20). These products contain volatile organic compounds (VOCs), which evaporate readily and be irritating to eyes, nose and throat. These products are flammable as well, and should be stored in a cabinet, which meets the criteria set forth by the National Fire Protection Association (NFPA) (NFPA, 1996).

Rooftop Exhaust Vent Bird Screen, Note Gaps between Screen and Housing

15. Have a chemical inventory done in all storage areas and classrooms. Properly store flammable materials in a manner consistent with the local fire code. Discard hazardous materials or empty containers of hazardous materials in a manner consistent with environmental statutes and regulations. Label chemical containers with the chemical name of its contents. Follow proper procedures for storing and securing hazardous materials.

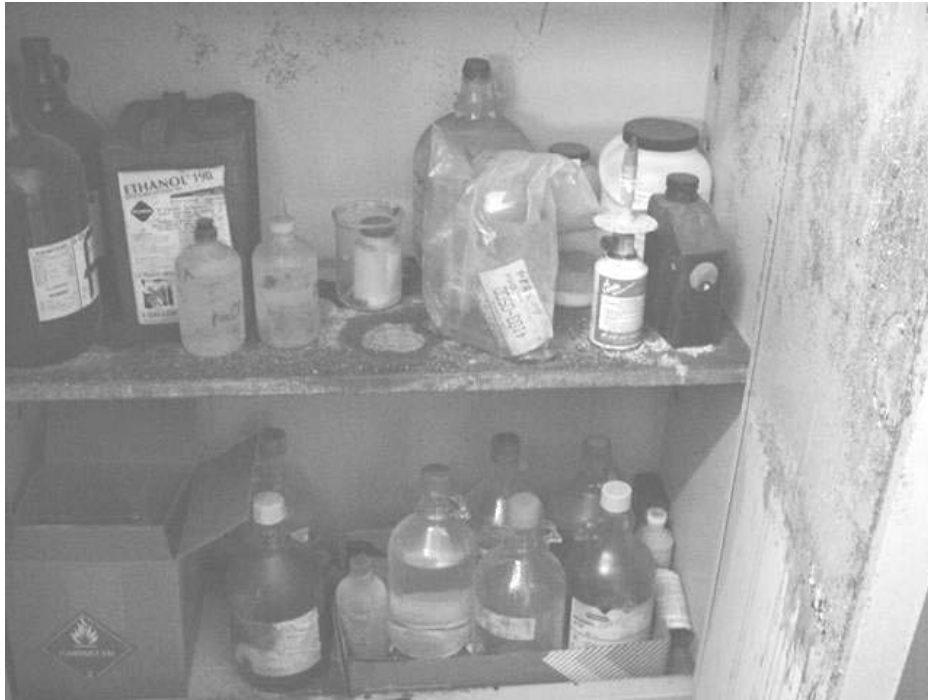
Picture 21

- Bottles of acids were stored in close proximity to alkaline materials (bleach).
- Crystallized spillage from unknown chemicals was coating the interior of the flammable cabinet. The interior of the cabinet has begun to corrode from exposure to off-gassing chemicals (see Picture 21).
- Flasks containing chemicals were sealed with plastic or glass stoppers, which can lead to the slow evaporation of materials from these containers.
- Some bottles were missing labels.
- Flasks filled with chemicals are labeled by chemical formula and not name.
- Chemicals in the storeroom are stored on shelves without any barriers/guardrails to prevent bottles from falling.

Rusted/Corroded Container of Paint Thinner

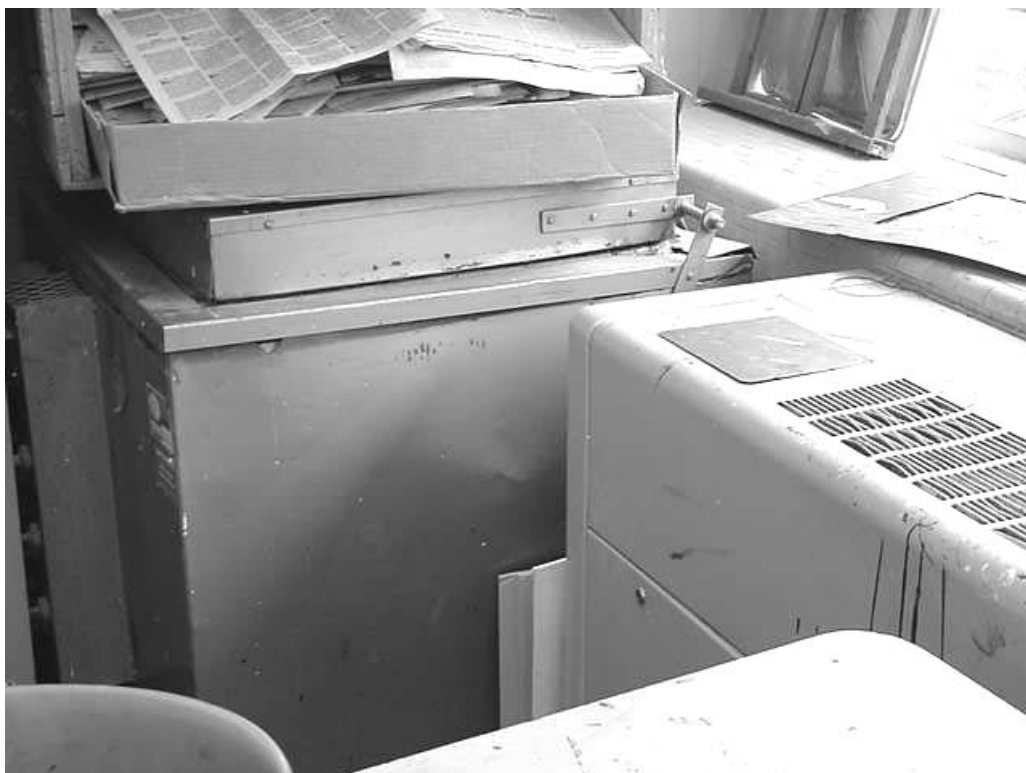
Picture 22

The art room of the annex building contains an unused pottery kiln, located next to the univent (see Picture 22). The exterior of the kiln is corroded, exposing a crumbling material (see Picture 23). Pottery kilns may contain insulation in the roof and wall cavities, which can contain asbestos (HSE, 1996). It should be determined if this material has been tested for asbestos in accordance with the school's asbestos hazard emergency response act (AHERA) management plan. It would also be advisable to relocate the kiln away from the univent.

Interior of Flammable Cabinet, Note Corroded Walls and Shelving and Crystallized Material on Shelf

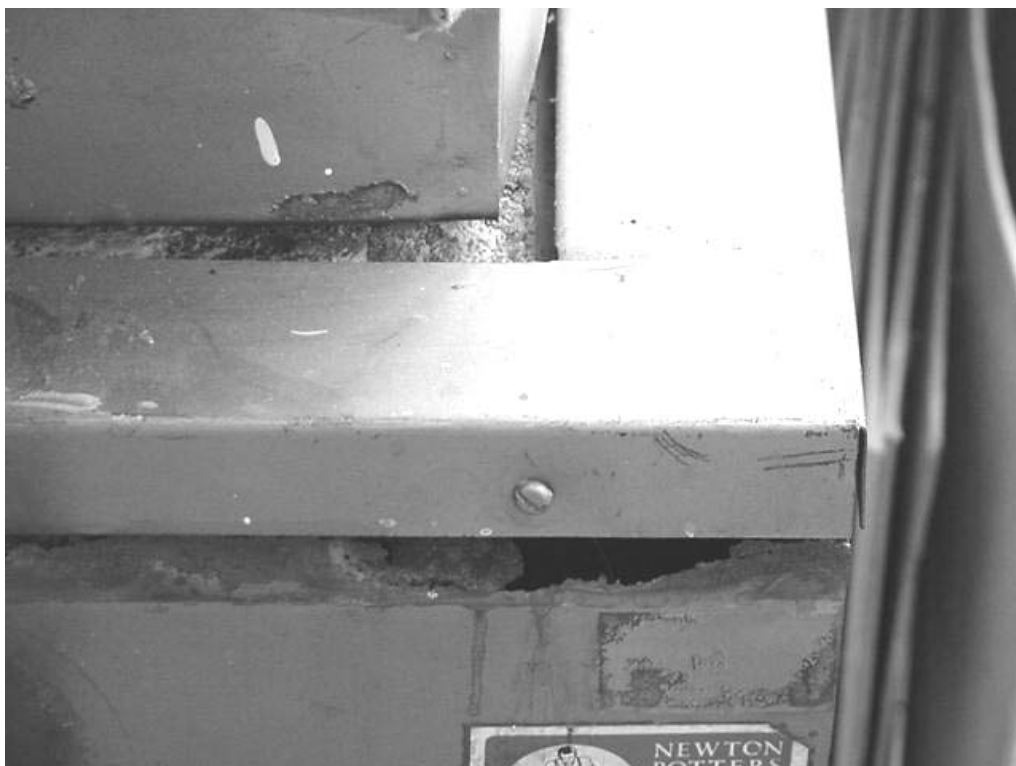
Picture 23

Unused Kiln in Art Room – Note Proximity to Univent

13. Replace/repair woodshop door to prevent woodshop odors from penetrating into adjacent areas of the school.
14. Ascertain whether crumbling material inside the kiln in Picture 23, contains asbestos and encapsulate or dispose of in an appropriate manner consistent with Massachusetts hazardous waste laws.

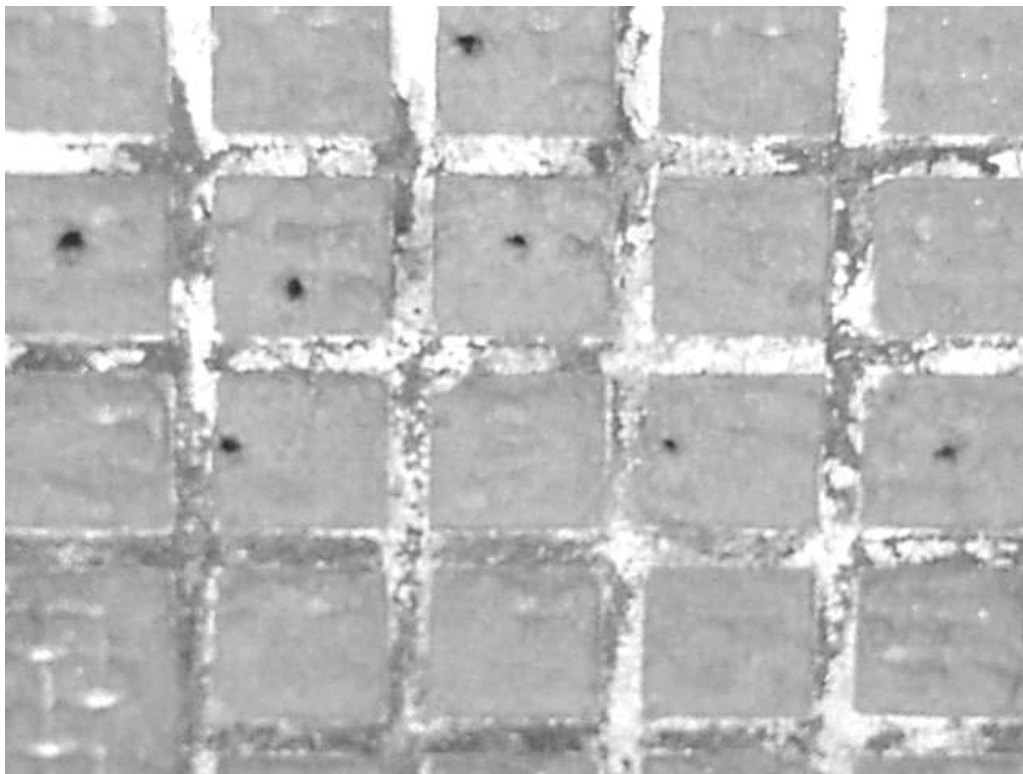
Picture 25

Finally, a number of restroom exhaust vents were either not operating, drawing weakly or sealed with sheet metal or clogged with debris (see Pictures 25 & 26). Exhaust ventilation is necessary in restrooms to remove moisture and to prevent restroom odors from penetrating into adjacent areas.

Accumulated Items in Classroom

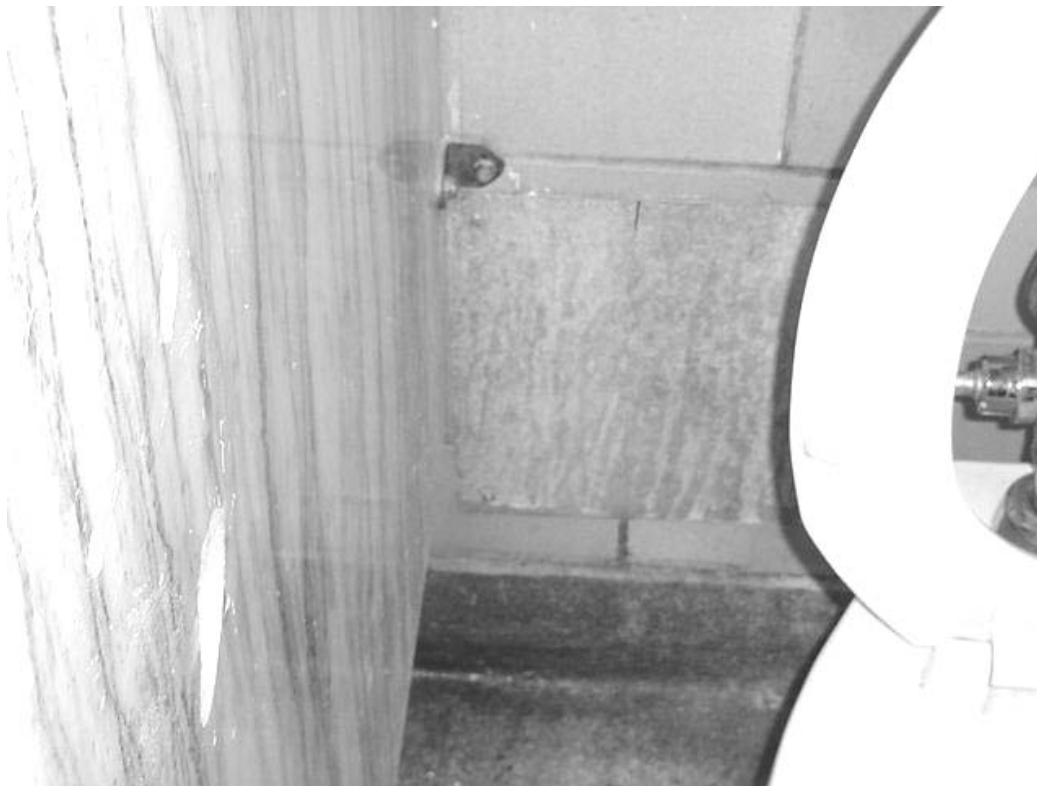
Picture 26

Close-Up of Restroom Exhaust Vent Occluded with Dust and Debris
